# **2016 Engineering Assessments of Coal Combustion Residual (CCR) Facilities, Intermountain Power Plant**

Intermountain Power Service Corporation (IPSC)

October 17, 2016

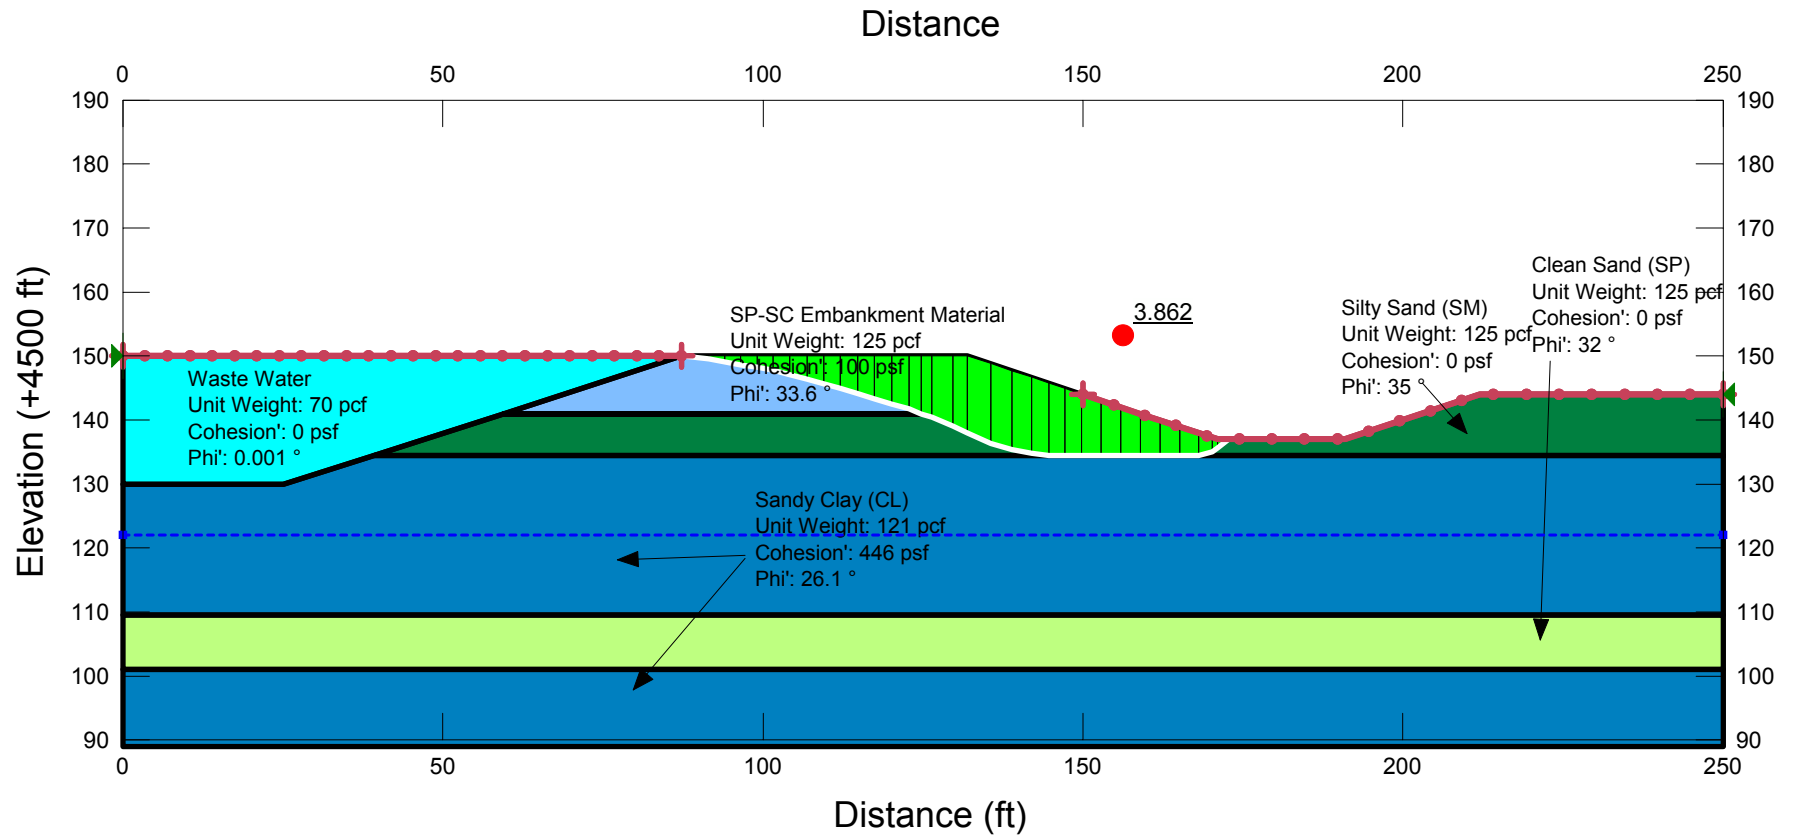
Figure B-13

## Cross-section: South Embankment of Waste Water Basin Static Limit Equilibrium Analysis

Graphical results showing the calculated critical surfaces and factors of safety for various cross-sections are presented in Appendix B (Figure B-11 through Figure B-14), with the factors of safety also summarized on Table 3-1. As can be seen in the Table, the calculated static factors of safety under the long-term, maximum storage pool loading condition for the various potential critical sections are all at least 1.50. In the case of this unit, the maximum surcharge pool is essentially the same as the long-term maximum storage pool; consequently, separate factors of safety for the maximum surcharge pool were not calculated. The calculated seismic factor of safety for all cross-sections is at least 1.00. As such, we consider this unit stable with respect to slope stability.
